Power System Incident Report - Friday 13 August 2004

Prepared by: System Operations Planning &
Performance

Date: 28 January 2005

FINAL REPORT

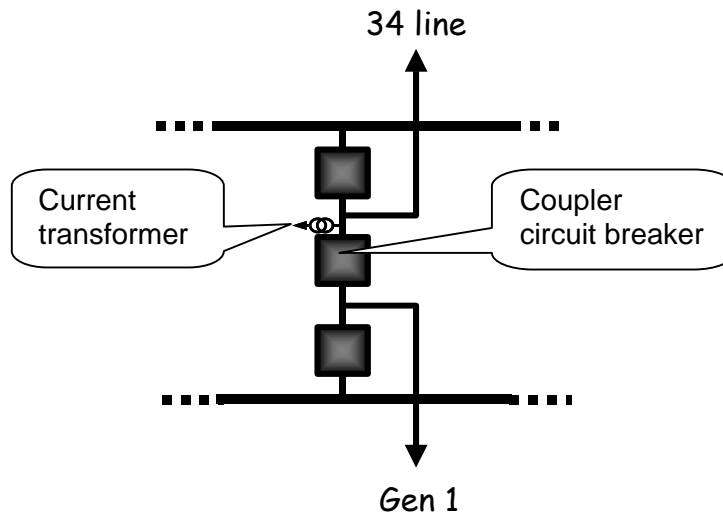
Figure 1-1: Number 1 bay of Bayswater 330 kV Switchyard¹

At 21:41 hrs on Friday 13 August 2004, a current transformer in the number 1 bay at Bayswater Power Station switchyard failed and later exploded. The number 1 bay at Bayswater Power Station switchyard contains three 330 kV circuit breakers which connect the 34 line to Liddell Power Station, and the number 1 generating unit at Bayswater Power Station, as indicated in figure 1-1.

The current transformer that failed was a red phase unit adjacent to the coupler circuit breaker in the number 1 bay.

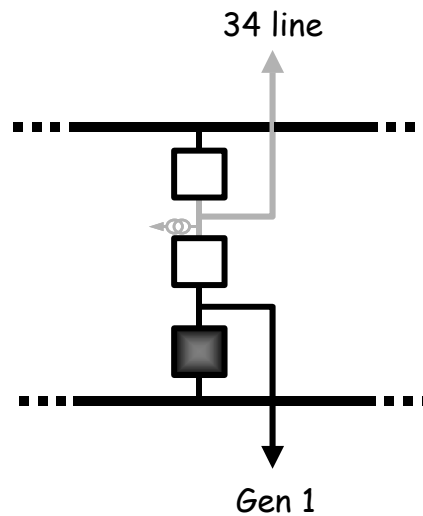
Figure 1-2: Fault cleared by 34 line protection

The fault on the current transformer was detected by the protection systems on the 34 line, which acted automatically to open the 34 line circuit breakers both at Bayswater Power Station and at Liddell Power Station. The fault was cleared in 83.5 msec, which is within design expectations. The current transformer fault was then isolated from the power system by the open circuit breakers at Bayswater Power Station as indicated in figure 1-2, and at Liddell Power Station.

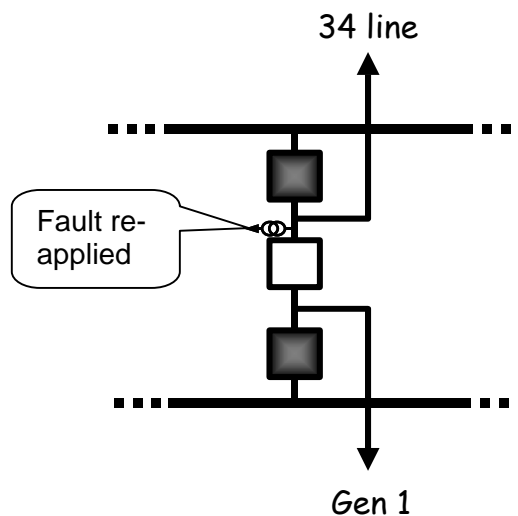
Figure 1-3: Main bus circuit breaker auto re-close

15 seconds after the initial fault, the auto re-close on the 34 line operated as designed and automatically closed the main bus circuit breaker as indicated in figure 1-3.

The fault on the current transformer was still present, and the auto re-close of the main bus circuit breaker resulted in the fault being re-applied to the power system for a second time.

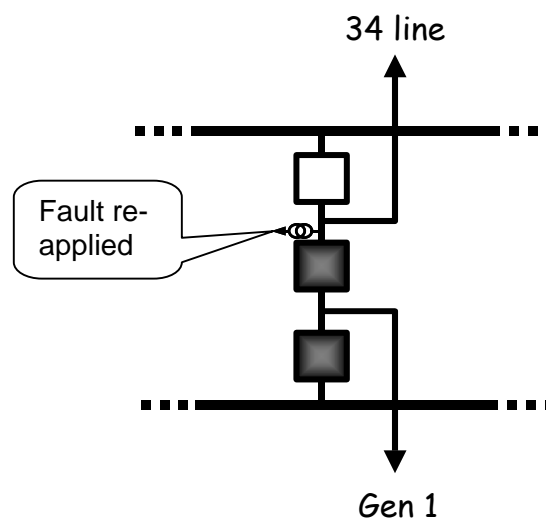
Figure 1-4: Coupler circuit breaker auto re-close

16 seconds after the initial fault, the auto re-close on the 34 line operated to automatically close the coupler circuit breaker as indicated in figure 1-4. The auto-reclosure performed as designed, but one of the scheme's intended features (inhibiting the closure of the coupler circuit breaker reclosure following an unsuccessful reclose attempt using the line circuit breaker) was not effective. TransGrid has advised that action has now been taken to eliminate reclosure of coupler circuit breakers following an unsuccessful reclosure of the line circuit breaker, at the Bayswater Power Station switchyard, and at other similarly configured switchyards in New South Wales.

As the fault on the current transformer was still present, the auto re-closure of the coupler circuit breaker resulted in the fault being re-applied to the power system for a third time. This third application of the fault did not contribute to further automatic under-frequency load shedding.

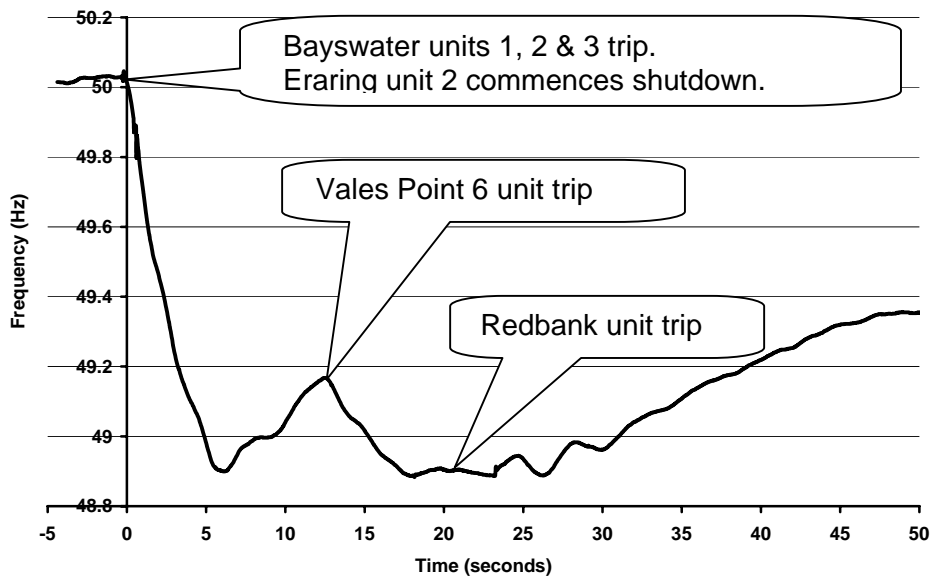
Figure 1-5: Power System Frequency

This sudden loss of generation caused the power system frequency to fall rapidly and within approximately 6.5 seconds, was down to 48.9 Hz (see figure 1-5). The frequency then began to recover as automatic under frequency load shedding commenced across Queensland, New South Wales, Victoria and South Australia.

When Vales Point unit 6 tripped, the power system frequency, which had been increasing due to the under frequency load shedding, began to fall again. The frequency continued to fall to a minimum value of 48.87 Hz, resulting in additional amounts of under-frequency load shedding.

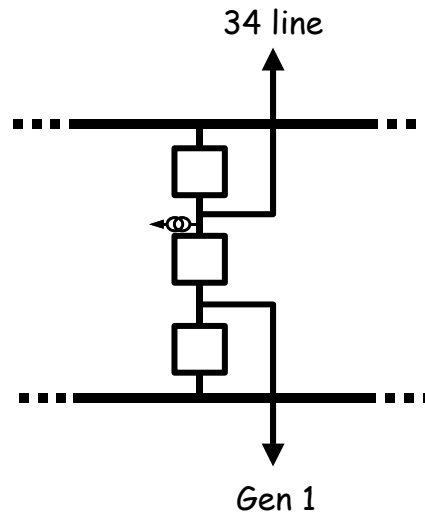
Figure 1-6: Generating unit 1 circuit breaker open

At one minute, 58 seconds after the initial fault, the Bayswater number 1 generating unit transformer circuit breaker opened as shown in figure 1-6. TransGrid have advised that this circuit breaker opened due to inter-zone protection as a result of a new fault. Although TransGrid has not been able to exactly determine the location of this new fault, they are of the view that the opening of the Bayswater number 1 generating unit transformer circuit breaker was caused by an explosion and subsequent fire in the switchyard that was due to the original current transformer failure.

Note that as the number 1 generating unit at Bayswater had already tripped, this circuit breaker event did not impact on generation output.

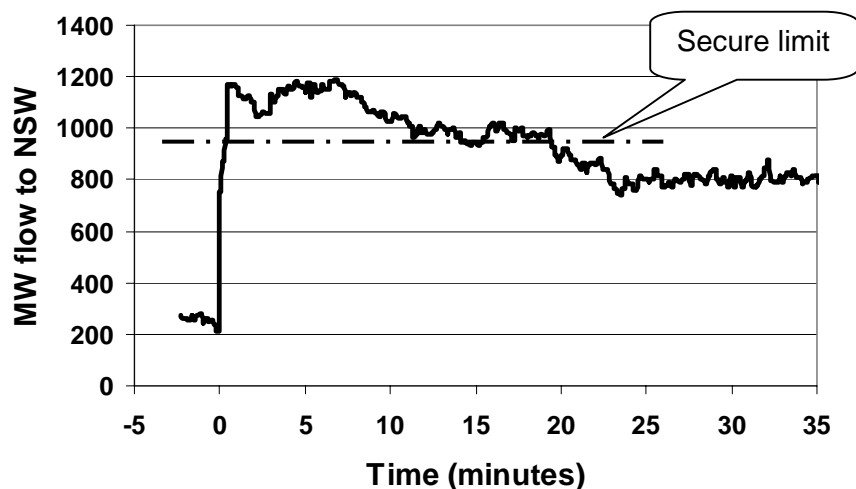
Figure 4-1: QNI Power Flow

Following the loss of the generation in New South Wales, the power transfer on QNI increased from 213 MW to 1188 MW towards New South Wales, as shown in figure 4-1.

Immediately following the loss of the New South Wales generating units, the power transfer from Queensland to New South Wales was above the secure limit⁷ of 950 MW. NEMMCO believes (on the basis of the analysis discussed below) that in this insecure state, any further loss of a large generating unit south of the Queensland – New South Wales border could have resulted in QNI tripping and the separation of Queensland from the other NEM regions. The QNI transfer was restored to a level within the secure limit in about 15 minutes, which is within the 30 minutes objective as established in the Code.

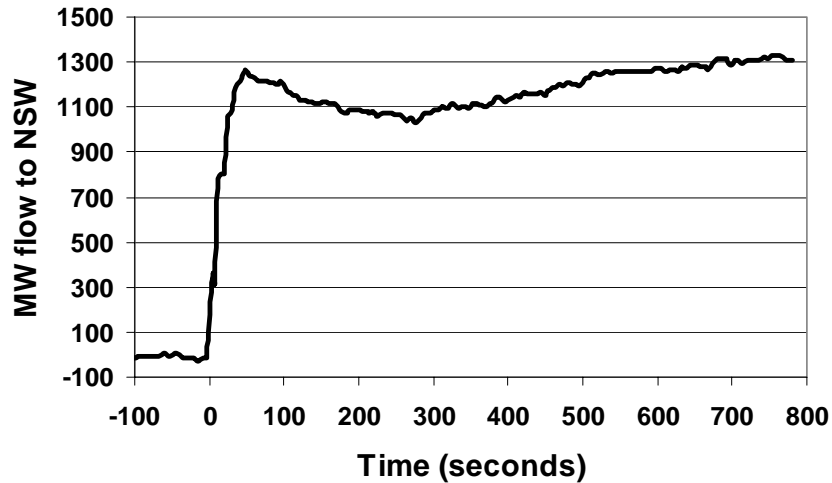
Figure 4-2: Power flow Snowy to NSW

transfer capability of this interconnector which was approximately 3000 MW at that time.

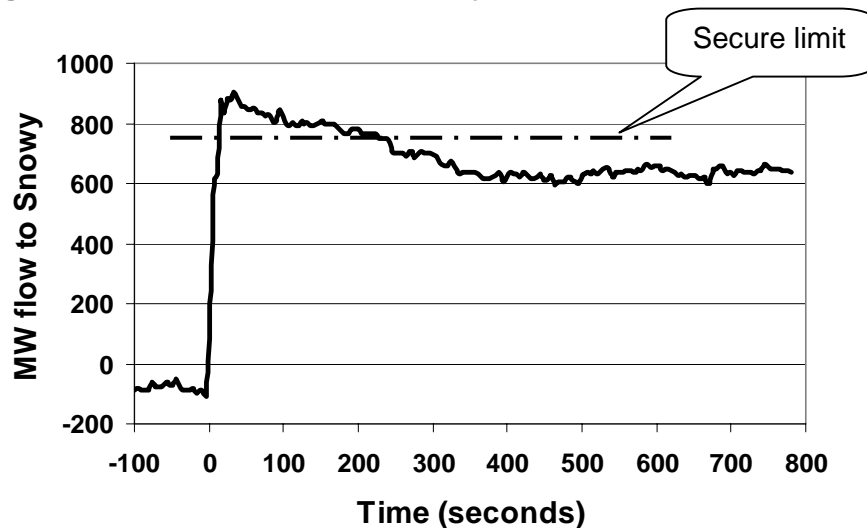
Figure 4-3: Power Flow Vic to Snowy

The power transfer on the Victoria to Snowy interconnector increased from -100 to 905 MW, which was over the secure limit at the time of 760 MW. The power transfer on this interconnector was reduced below its secure level in a little under 4 minutes, which is within the Code requirement of 30 minutes.

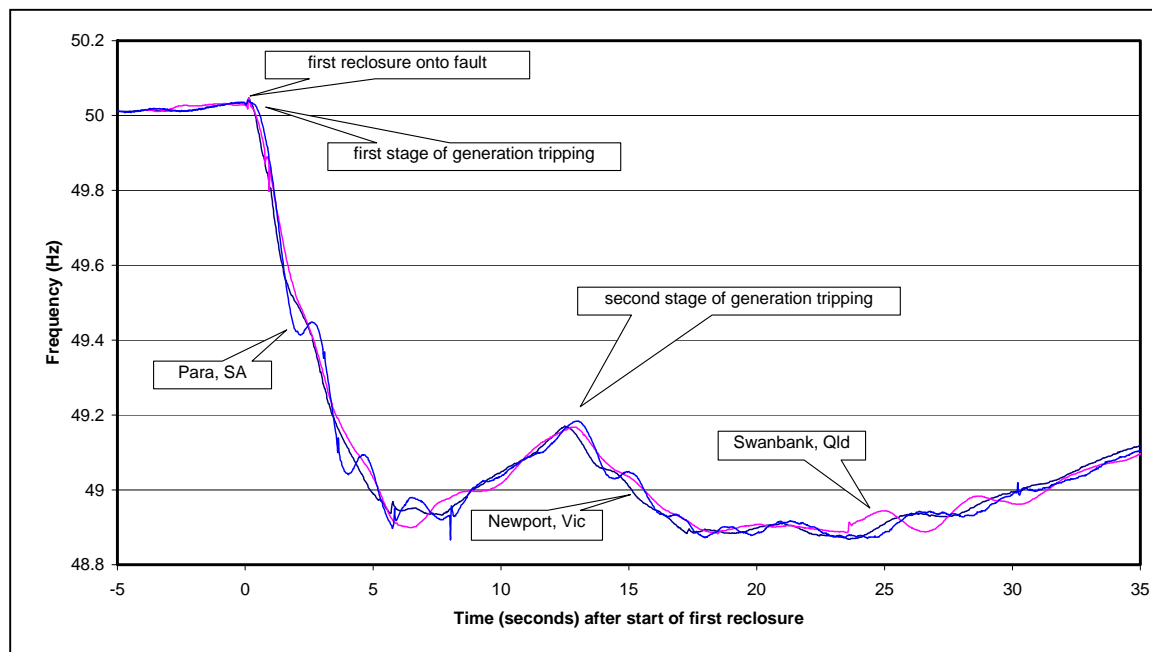
Figure 1 Frequency during the disturbance

In Figure 1 and in the details provided below, time has been referenced to the start of the first reclosure onto the fault in the Bayswater switchyard. The first generation tripping occurred during this fault. A second stage of generation tripping occurred about 13 seconds later.

The high speed measurements show that the frequency in different regions differ by up to about 0.05 Hz, and the times of minima vary by up to 6 seconds. The times of greatest difference between the Swanbank and Newport frequency traces are evidence of oscillation excited by the load shedding in Queensland. All measurements also show some small transients, which are thought to be due to measurement technique, possibly as a result of abrupt voltage variations.

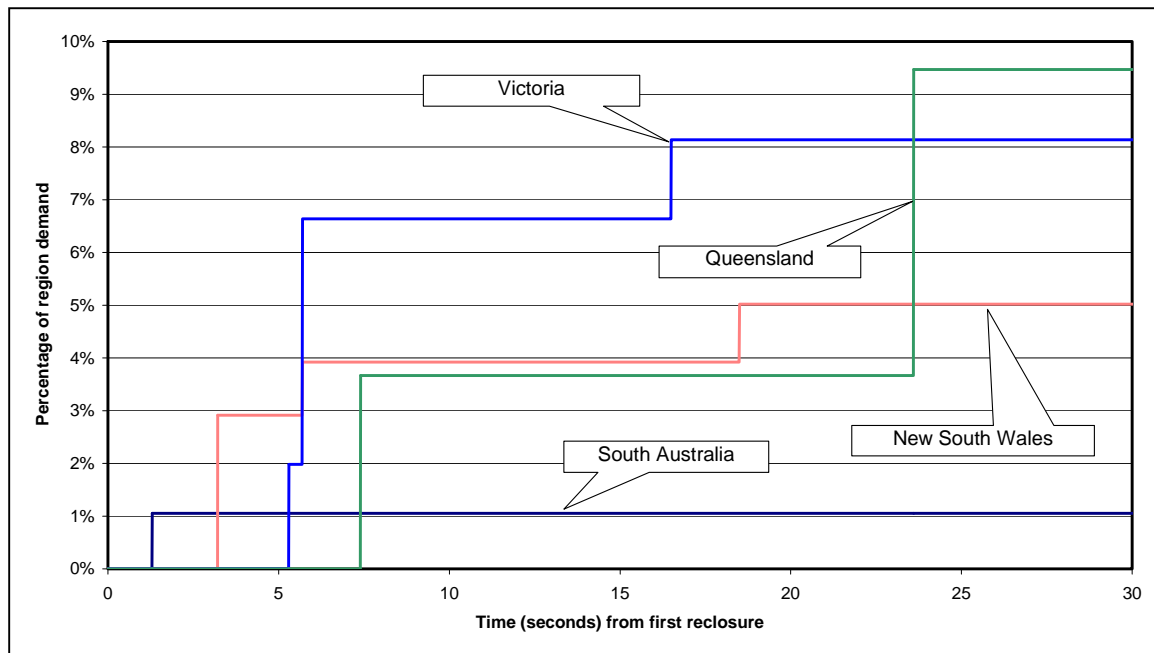
Figure 2 Progression of load shedding

The progression of the load shedding during the disturbance expressed in percent of region demand is shown in Figure 2.

This assessment shows that Queensland provided more load shedding than would be expected by equitable sharing. A contributing factor appears to be the relatively large size of the Queensland under-frequency load shedding blocks as a percentage of region demand.

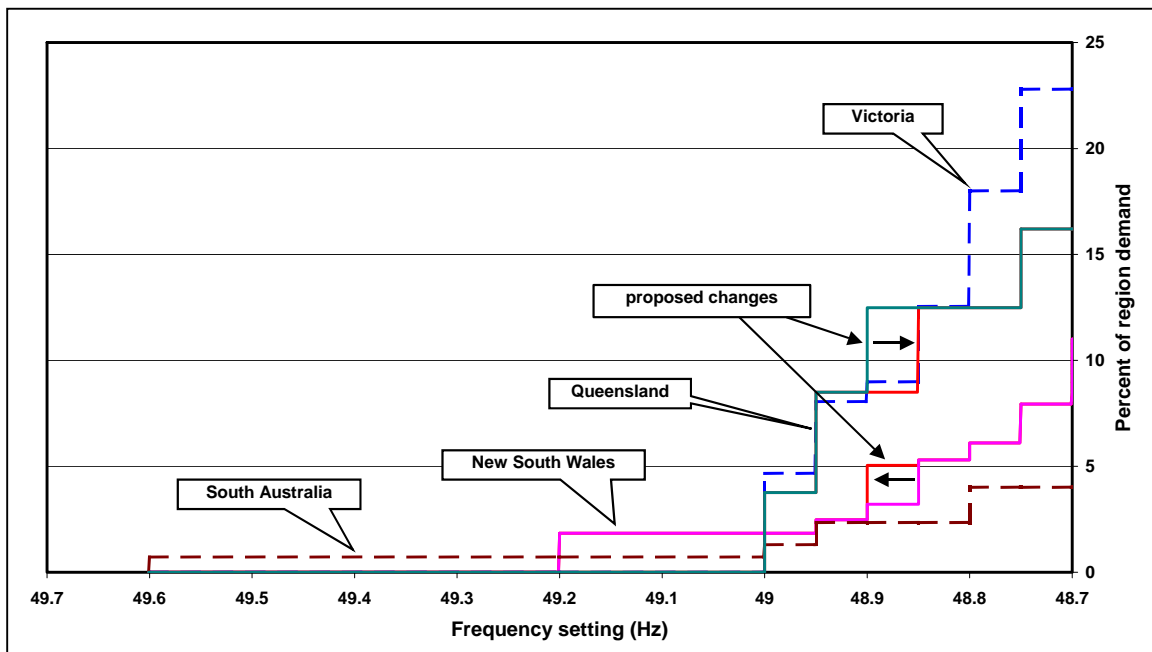
Figure 3 Balance of load shedding

Figure 3 shows that the imbalance between regions is quite significant. NEMMCO notes that the Queensland under-frequency load shedding block at 48.90 Hz extends beyond the others, and New South Wales and South Australia contribute less in proportion to their size. NEMMCO has therefore determined that the frequency settings of the Queensland block and a load block of similar size in New South Wales be exchanged as shown in Figure 3, as an interim improvement to the load shedding settings.

A full review of under-frequency load shedding across all regions is likely to take some time, and it is recommended that an interim minor adjustment be made to some under-frequency load shedding settings to address the most obvious imbalance. Figure 3 shows the accumulated load shedding amounts as a percentage of region historical maximum demand, plotted against frequency setting down to 48.7 Hz. In Victoria, new under-frequency load shedding facilities were installed at the end of September 2004, and the new settings have been used in this assessment for future conditions. Under-frequency load shedding blocks with time delays of 25 seconds or more (totalling approximately 800 MW in Victoria and Queensland) have been excluded because these are far less likely to trip.
